## The PWF history

## Case study – Cooperative housing

### Conclusions and Next steps

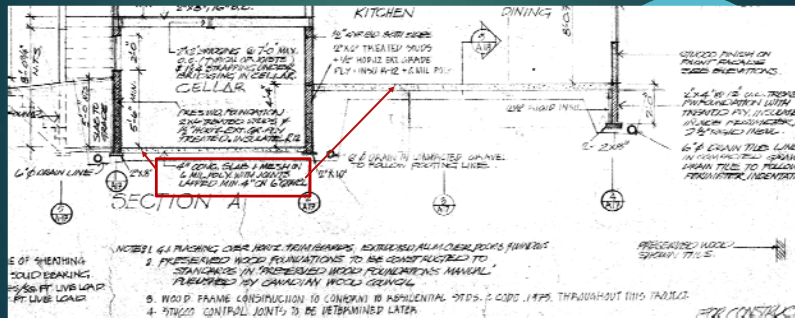
Built Nov. 1977

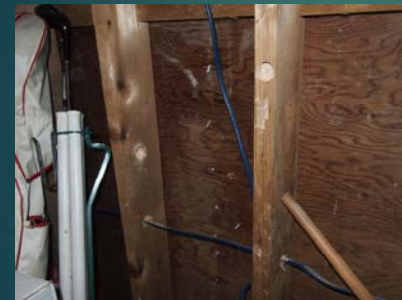
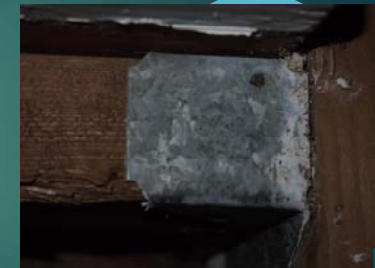
- ▶ Inspect the basements from the inside;
- ▶ No disturbance of the plywood or outer sheathing;
- ▶ Measure MC%
- ▶ Sample studs in at least 6 units
- ▶ Sample 2 separate locations in each foundation
- ▶ Recover cores from studs – one edge and one face
- ▶ Determining penetration and content for each core

- There is a need for a protocol for inspecting PWFs
- It should address separately PWFs
  - a) from before the CSA standard and
  - b) those after the introduction of the standard
- Early PWF lumber may be undertreated since the incising patterns were inadequate
