# Treated Wood in Aquatic Environments

A Specification and Environmental  
Guide to Selecting, Installing and  
Managing Wood Preservation Systems  
in Aquatic and Wetland Environments

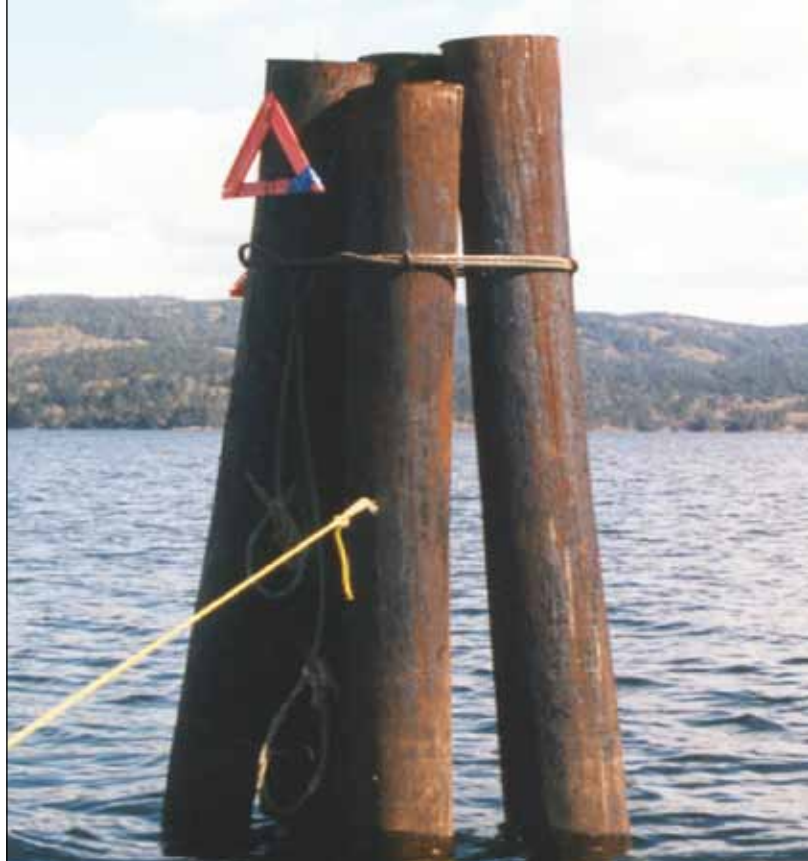
*New creosote-treated dolphin used  
to evaluate creosote in Sooke.*

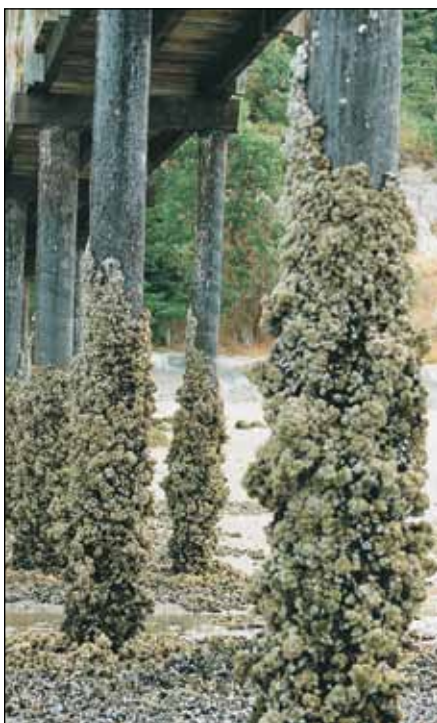
*The personal use pier shown here is constructed of creosote-treated piling with ACZA-treated walkways*
