Treated Wood in Aquatic Environments

A Specification and Environmental
Guide to Selecting, Installing and
Managing Wood Preservation Systems
in Aquatic and Wetland Environments

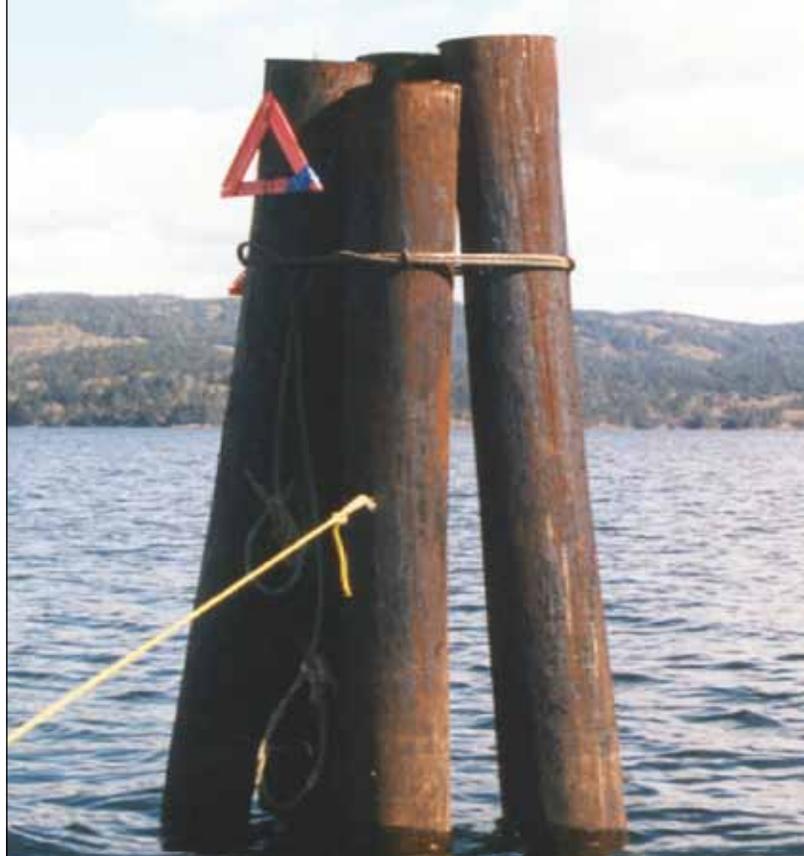
New creosote-treated dolphin used to evaluate creosote in Sooke.

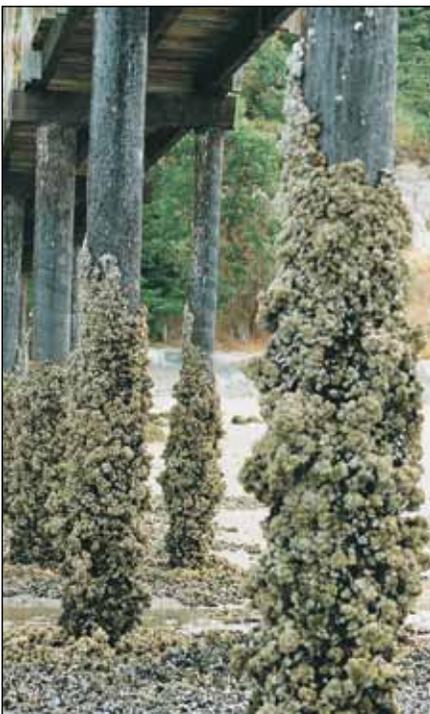
The personal use pier shown here is constructed of creosote-treated piling with ACZA-treated walkways
